Baring Bridge Replacement Project

Baring Community Public Open House

Project Presentation

January 26, 2019

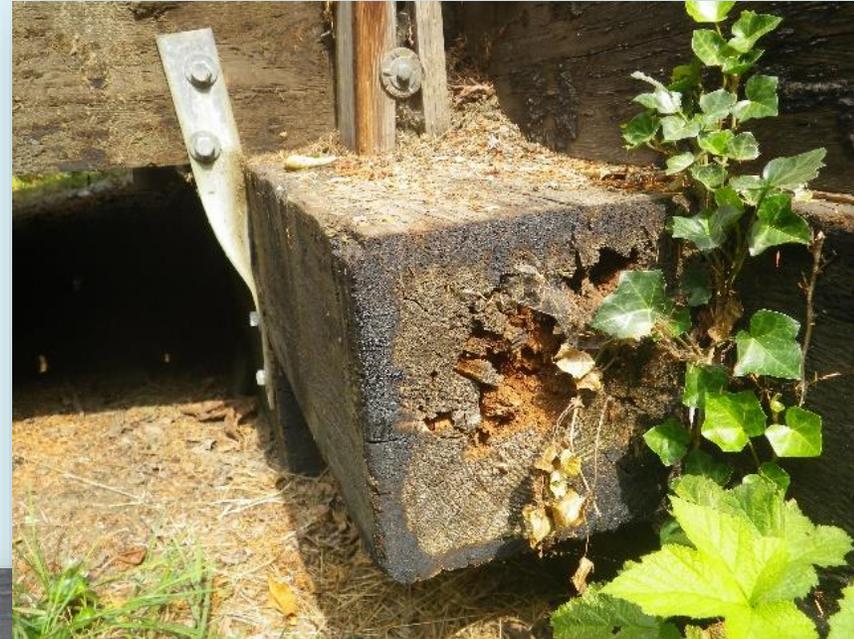
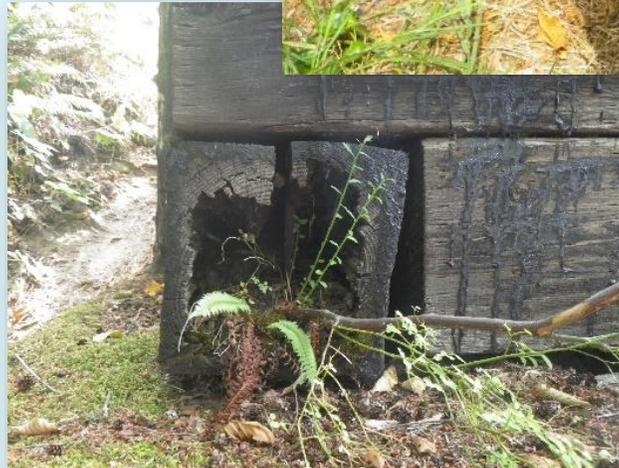
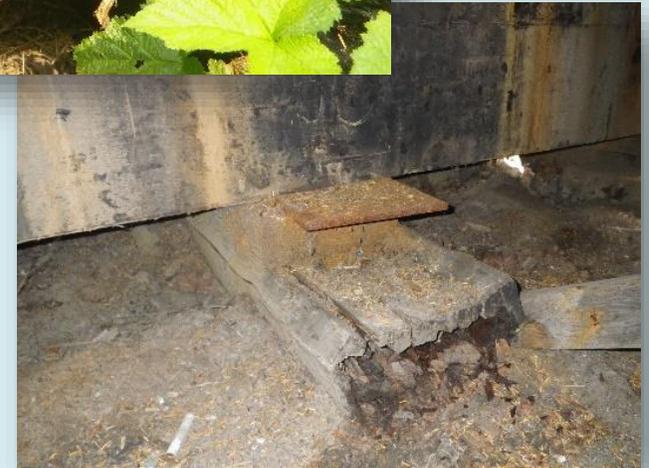
Bridge Needs to be Replaced

- Timber towers continue to rot
- Repairs are difficult and expensive

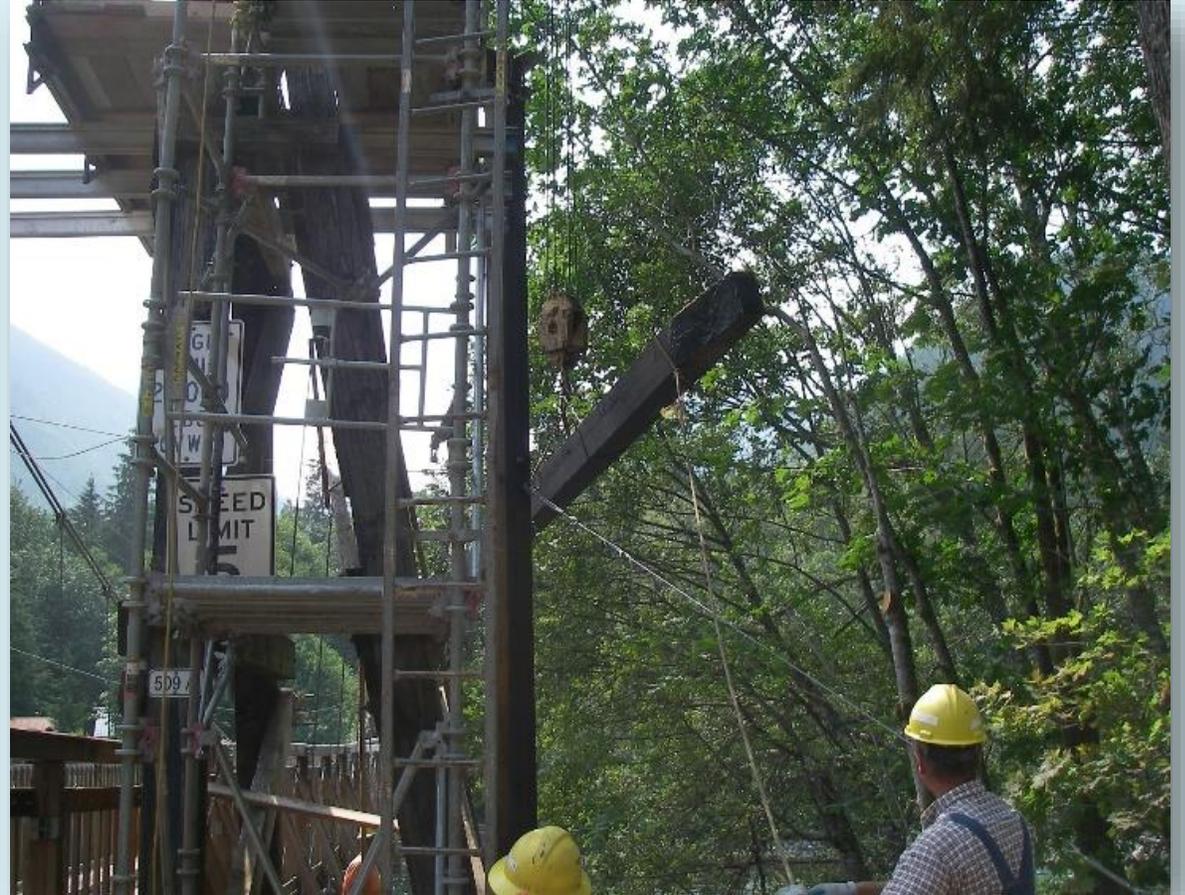
Column replacement in 2010

- In **1976**, two new cables were added to the bridge, and the North Approach was replaced
- In **1995**, new floor-beams, decking, concrete anchors, high strength hangers, and bridge rail system were added.
- In **2010**, a column and foundation sills were replaced on the North Tower of the bridge.
- In **2017**, new main span stringers and decking were added to the bridge. Retrofits were made to the floor-beams, South Tower, and timber at ground line.

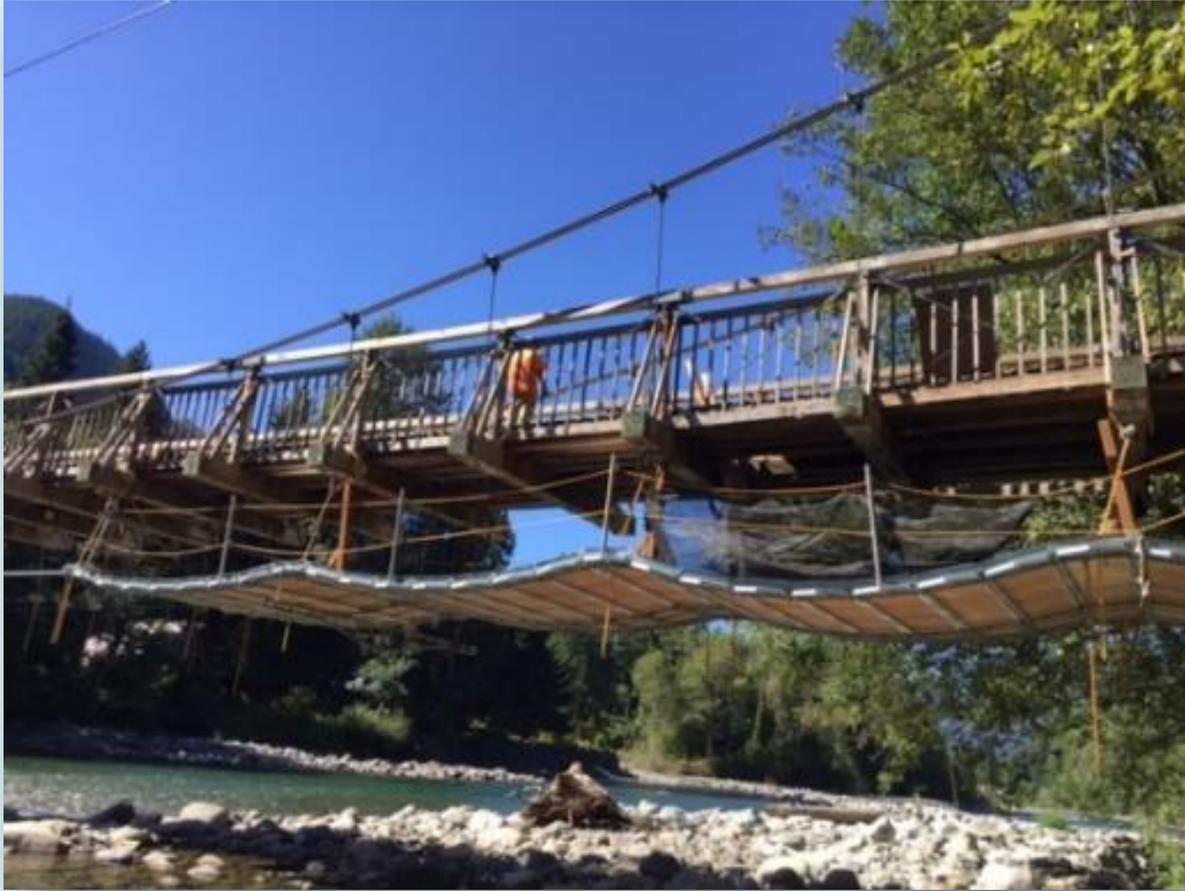
Suspended Work Platform

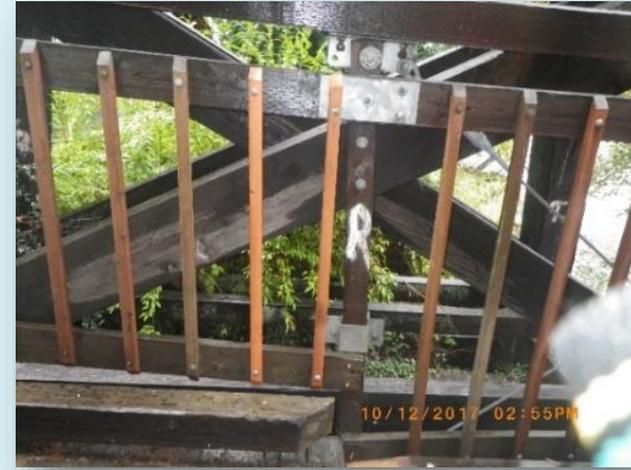
Repaired railing elements

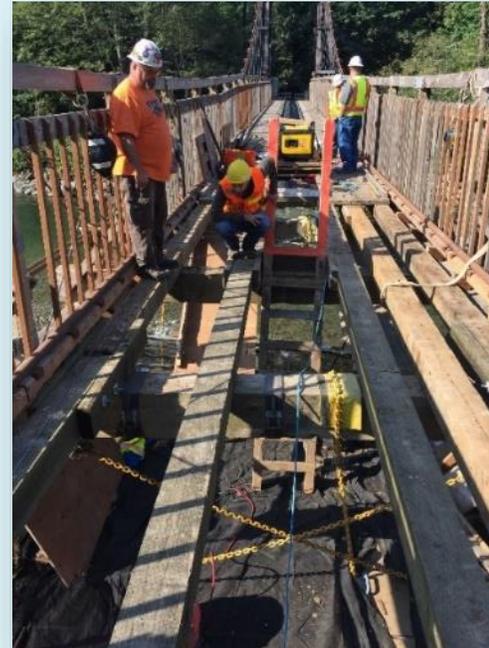
Replaced Stringers

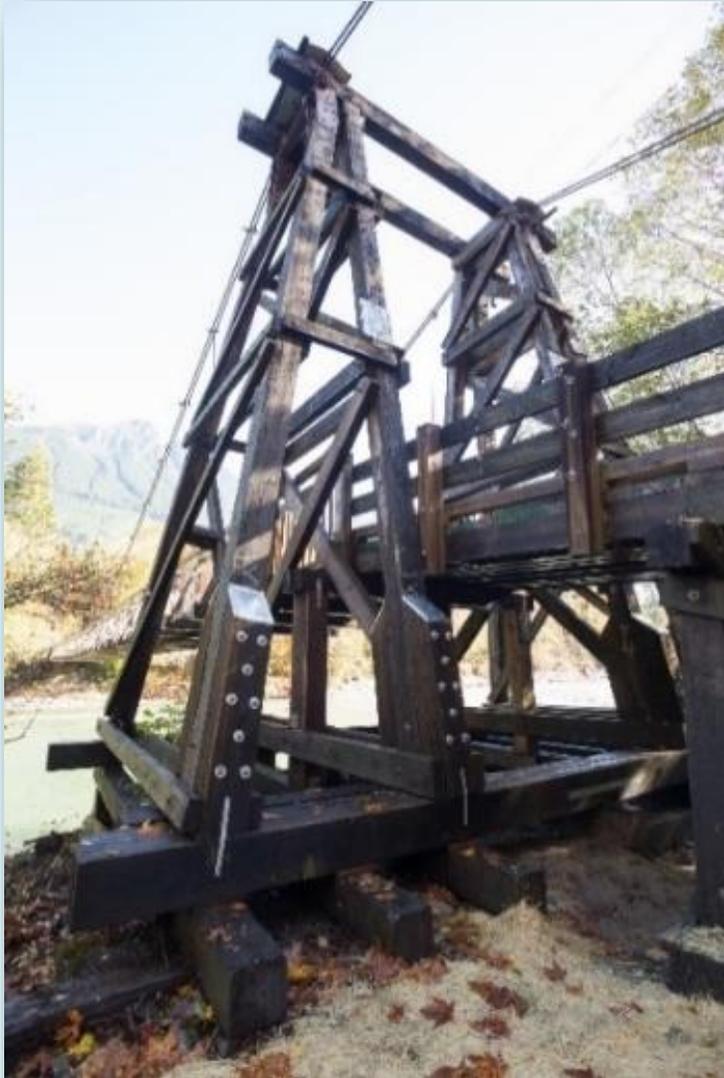
Tower Strengthening Retrofit

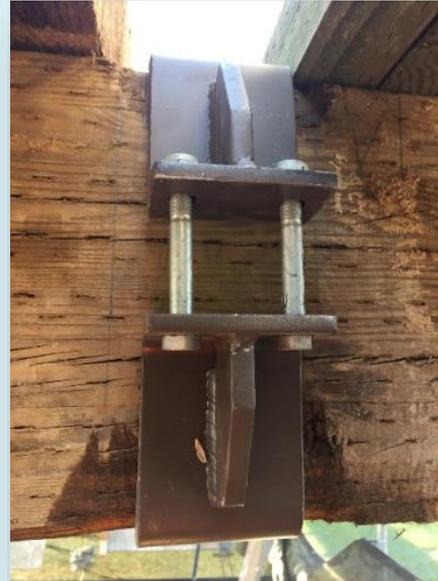
Steel Straps on Floor Beams

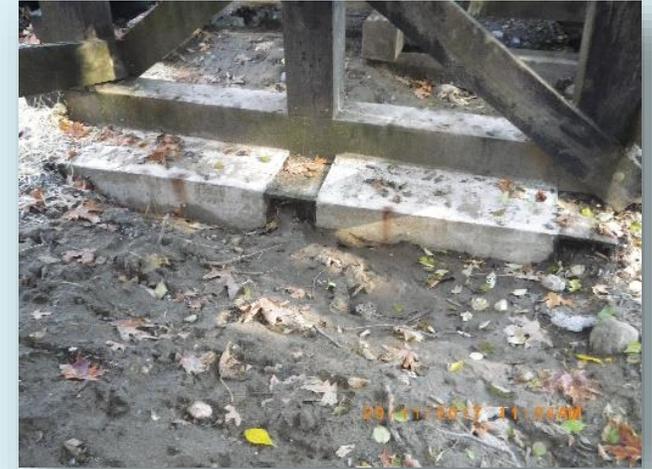
Timber Repairs at Ground Line

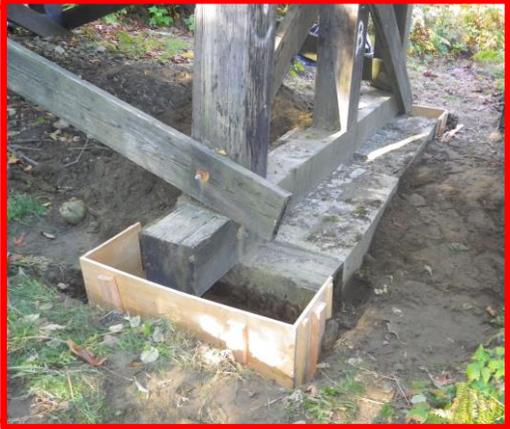
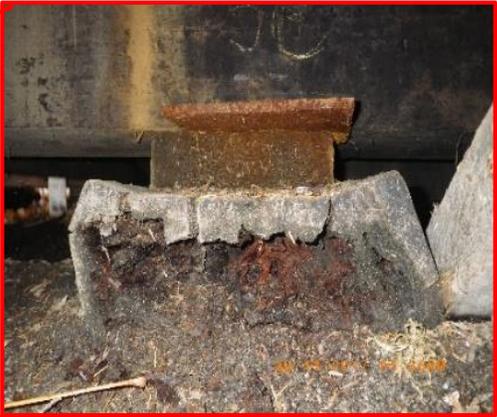
2018 Repairs

- Timber repairs at ground line

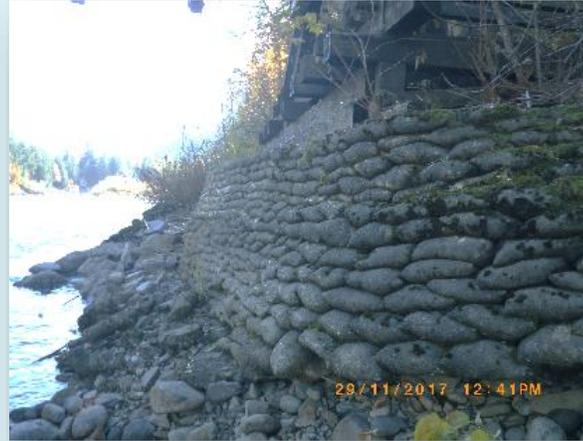
Scour pocket

- A scour pocket is developing at the South Tower of the bridge that will be addressed between 2019 – 2020.

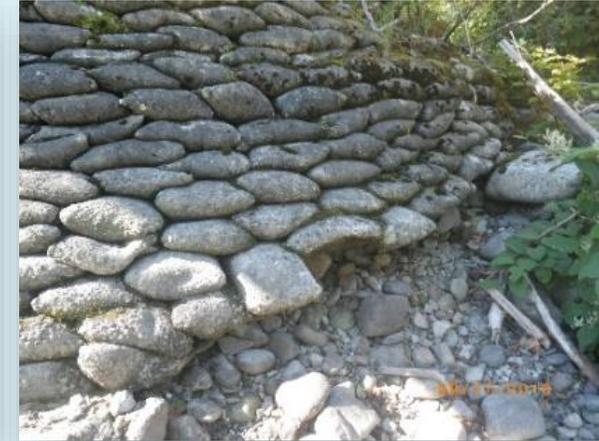
Scour pocket

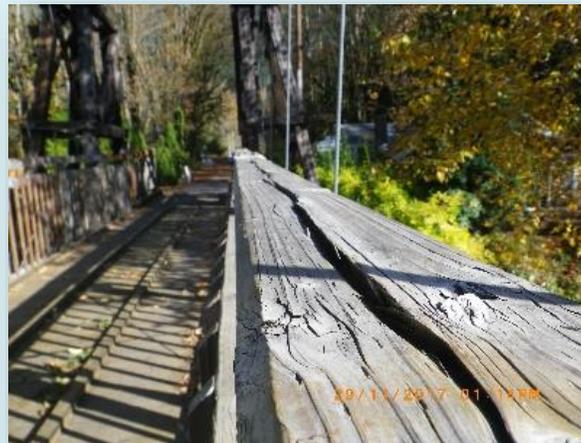
Split beam

- Future maintenance on the top of the deck is required to repair the bridge truss and railing.

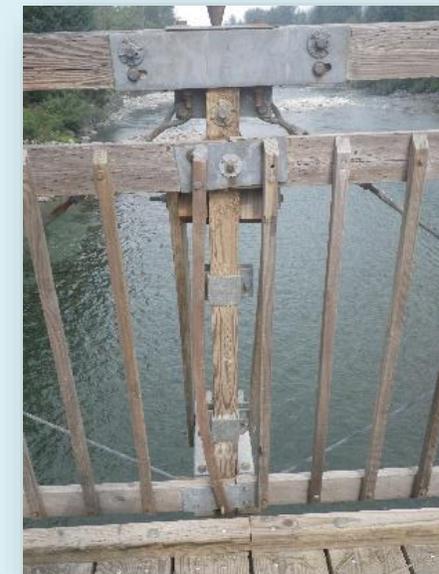
Broken fence posts

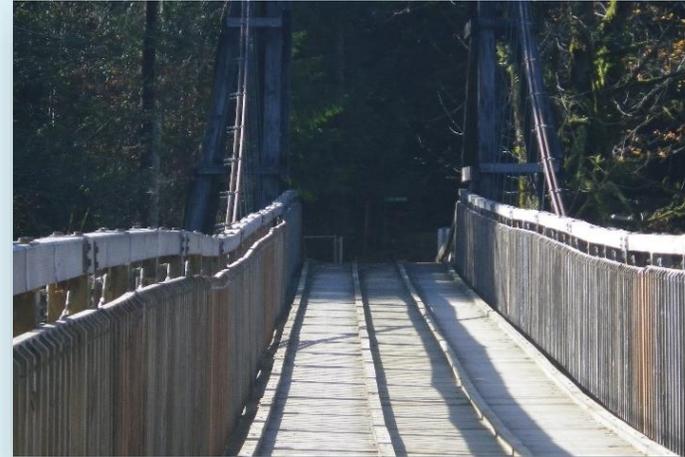
Deck sags under dead load

- Tighten cables to prevent the deck from sagging
- Clean and paint metal components
- Repair damaged anchor box
- Retrofit and/or replace aging timber members and other components of the bridge

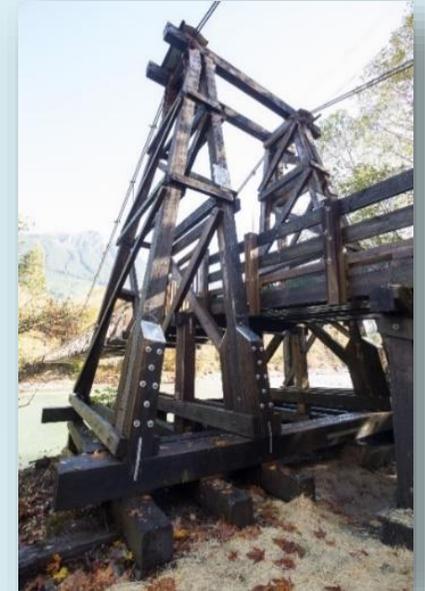
Bridge Tower

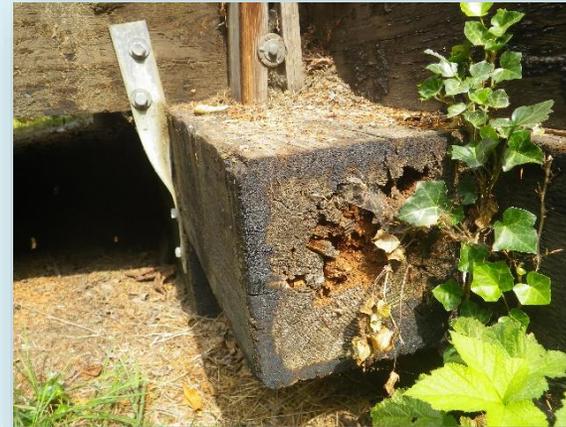
Aging timber member

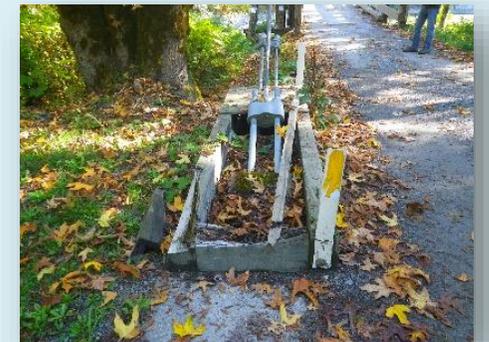
Damaged anchor box
